August 17, 2000

Area surveyed: North Canal

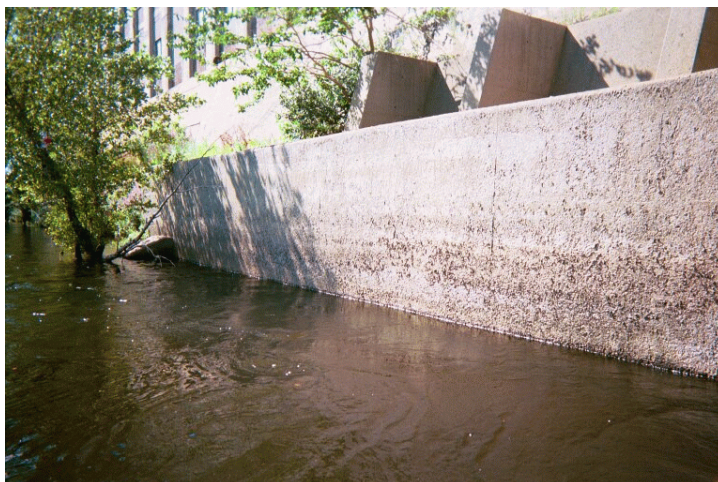
Pipe # 41:	Approximately 20' wide concrete culvert. Fully submerged. <i>Flowing, unable to estimate flow rate. Discharge is clear and has no odor.</i> Located behind a 7-story brick mill building with a concrete foundation at 300 Canal Street (Pacific Mills Industrial Complex).
-------------------	---

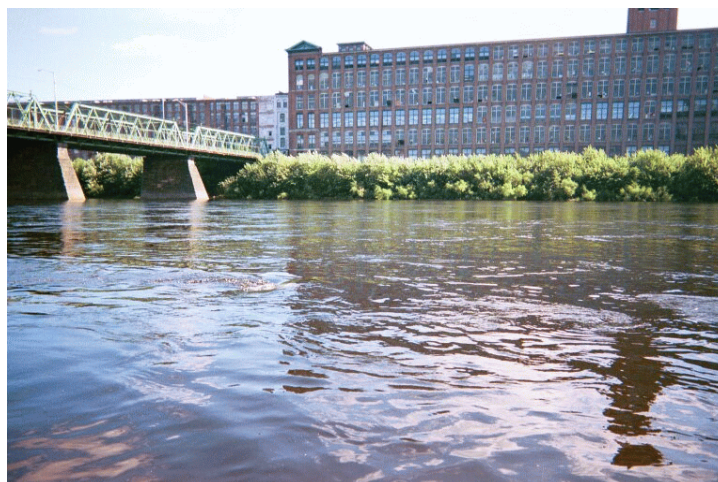
Pipe # 42:	Two approximately 12" diameter iron pipes. Located in the River approximately 10' from shore, just below the water surface. <i>Unable to determine if pipes are discharging due to strong current.</i>
-------------------	--

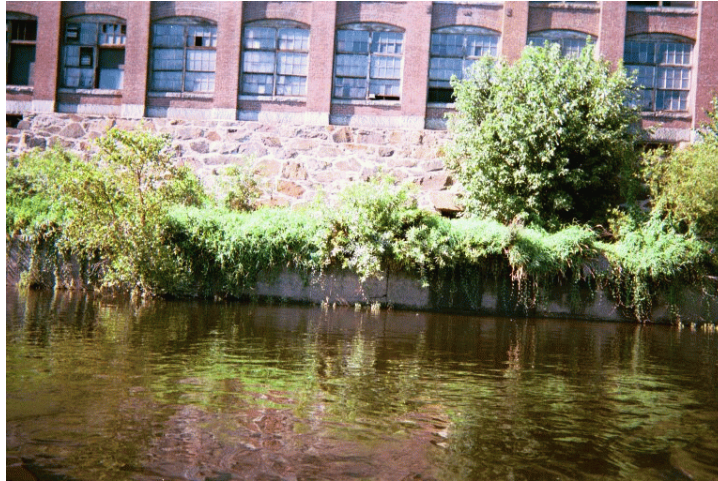
Pipe # 43:

Approximately 4' wide stone culvert. *Trickle flow*. Located in the foundation for the Southwick Building.

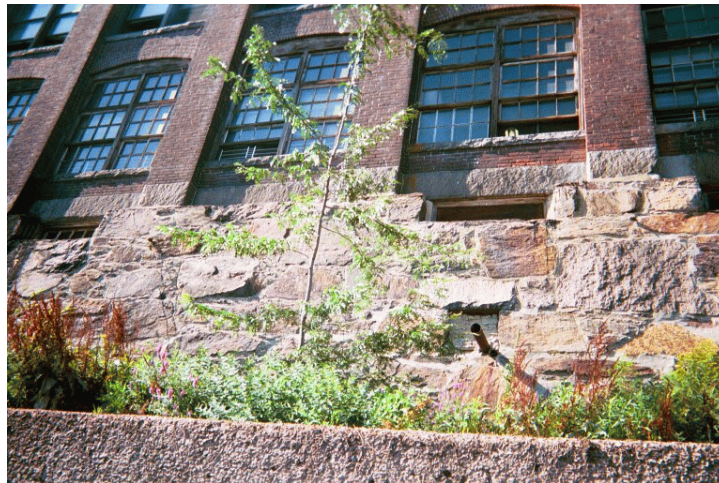
Pipe # 44:

Two (2) approximately 4" diameter iron pipes. Located approximately 30' apart in the foundation for the Southwick Building. No flow.

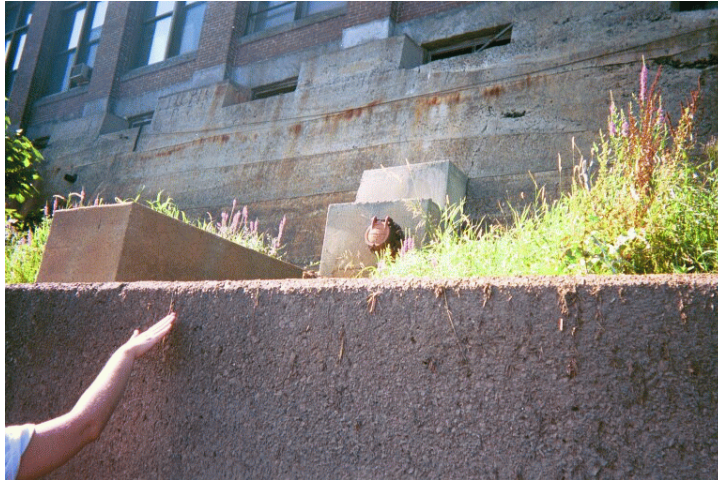
Pipe # 45:	Approximately 12" diameter iron pipe with flapper valve. Located in the foundation for the Southwick Building. No flow.
------------	---

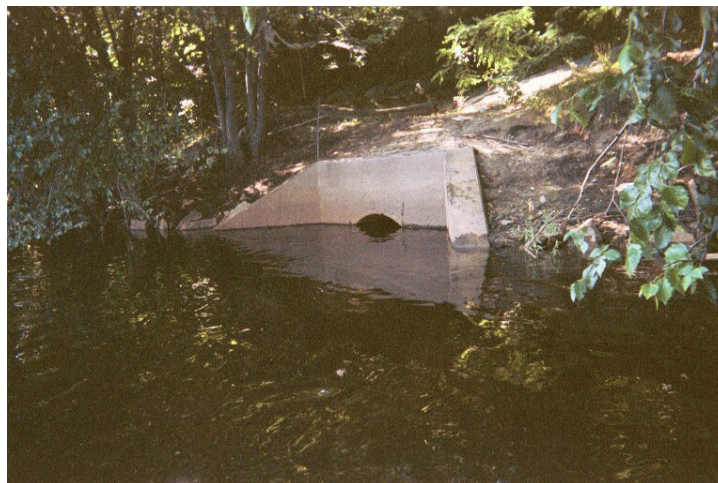
Pipe # 46:	Approximately 36" diameter concrete pipe. Partially submerged. Located in a wooded area. No flow.
------------	---

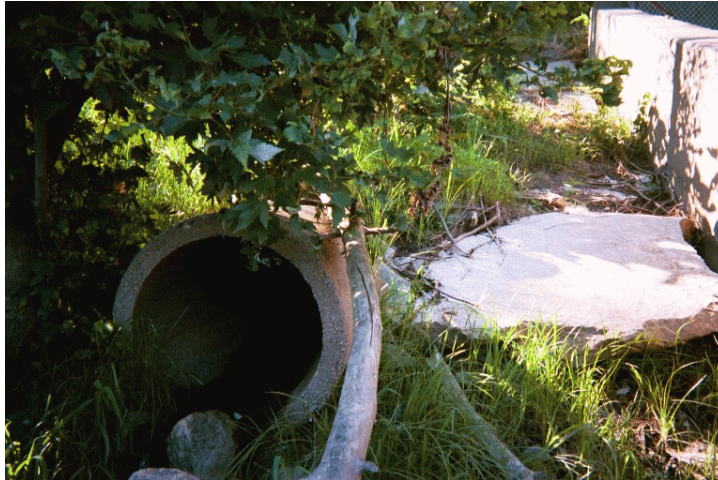
Pipe # 47:	Approximately 24" diameter concrete pipe. <i>Flowing approximately 5 gpm. Discharge is clear and has no odor.</i>
-------------------	---

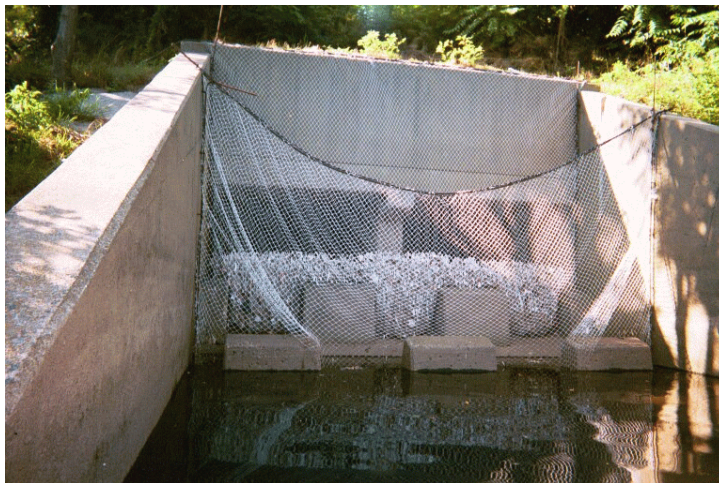
Pipe # 48:	Approximately 15' wide concrete culvert covered with netting. Paper and plastic debris caught throughout netting. Baffle piers located in front of the culvert. Strong sewage odor. No flow.
-------------------	--

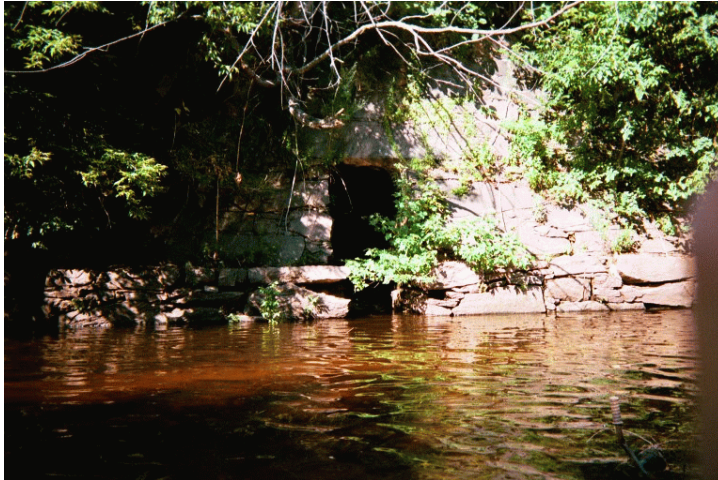
Pipe # 49:

Approximately 4' wide rectangular stone culvert. Partially filled with sand and debris. Located in a stone wall, at confluence of the North Canal and the Spickett River with the Merrimack River. No flow.

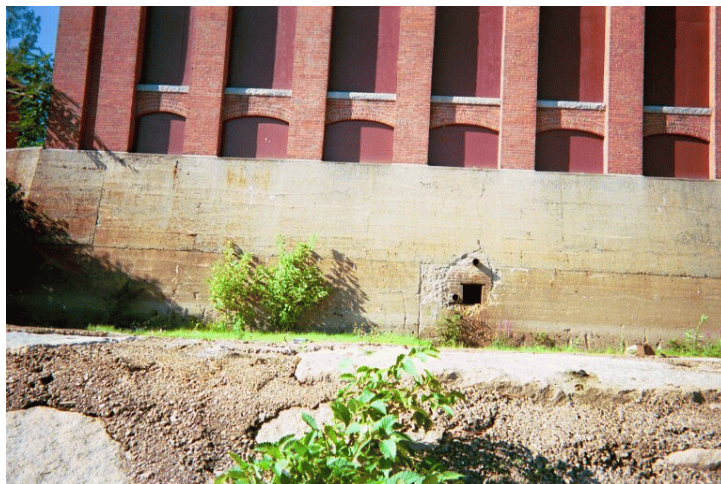
Pipe # 50:

Two approximately 4" diameter iron pipes and one approximately 12" diameter iron pipe. Located approximately 30' away from the River in the concrete foundation of a 4-story brick building. Three of the stories are boarded up with red wood. No flow.

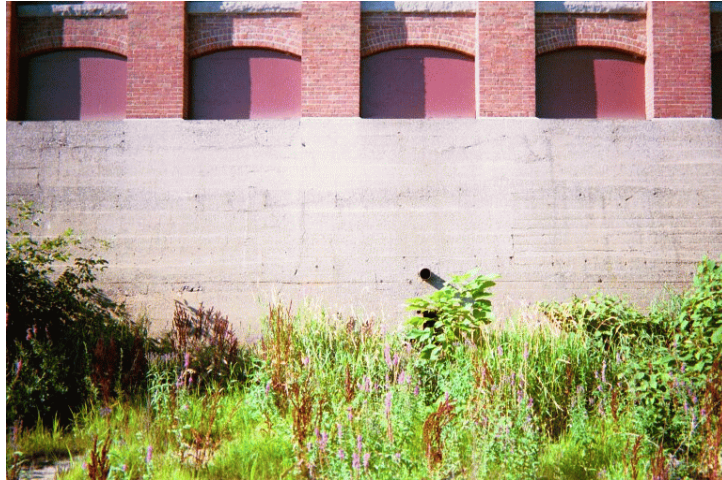
Pipe # 51:

Two approximately 4" diameter iron pipes and one approximately 24" brick culvert. Located in the same foundation as Pipe # 50. No flow.

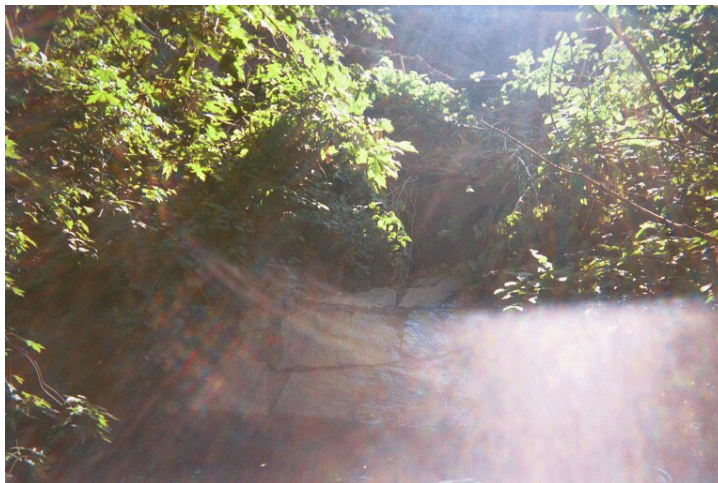
Pipe # 52:	Approximately 24" diameter concrete pipe. Located approximately 30' from the river in an inlet. <i>Trickle flow. Discharge is clear and has no odor.</i> Near inactive landfill on Incinerator Road
-------------------	---

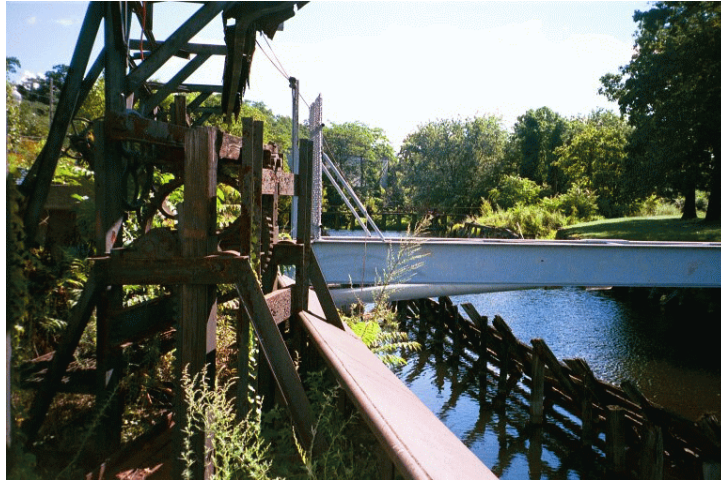
Pipe # 53:	Approximately 50' wide concrete culvert with multiple valves. Canal Street side. Across the canal from Ferrous Technology. No flow.
-------------------	---

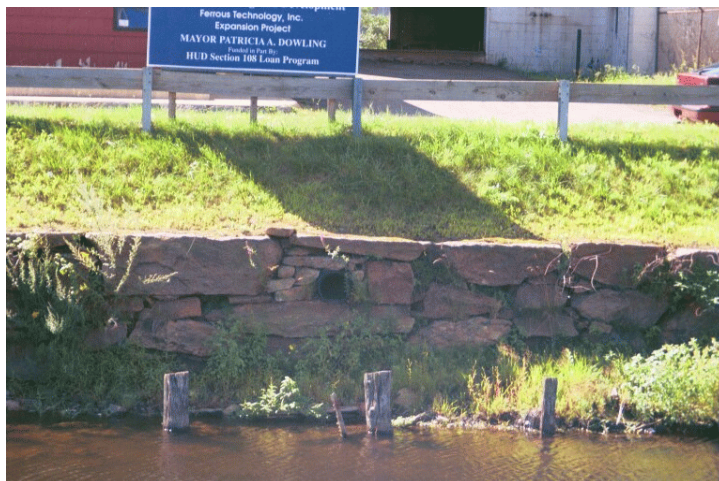
Pipe # 54:	Approximately 12" diameter iron pipe. In front of the red Ferrous Technology building. Island side. No flow.
------------	--

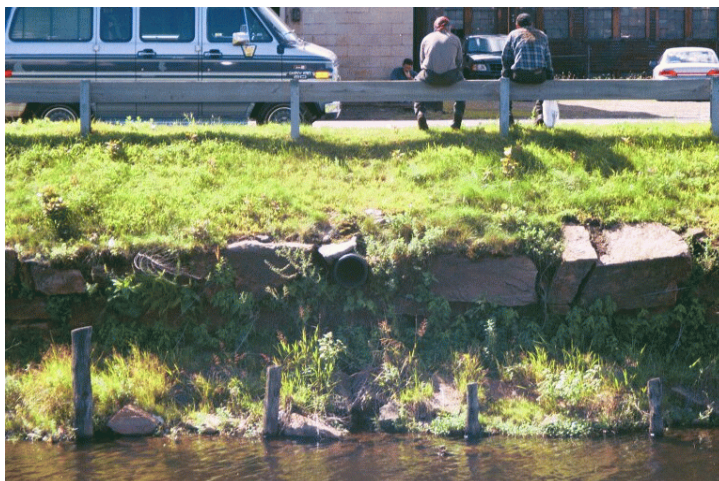
Pipe # 55:	Approximately 12" diameter corrugated black plastic pipe. In front of cinder block building with the "Ferrous Technology" sign. Island side. No flow.
------------	---

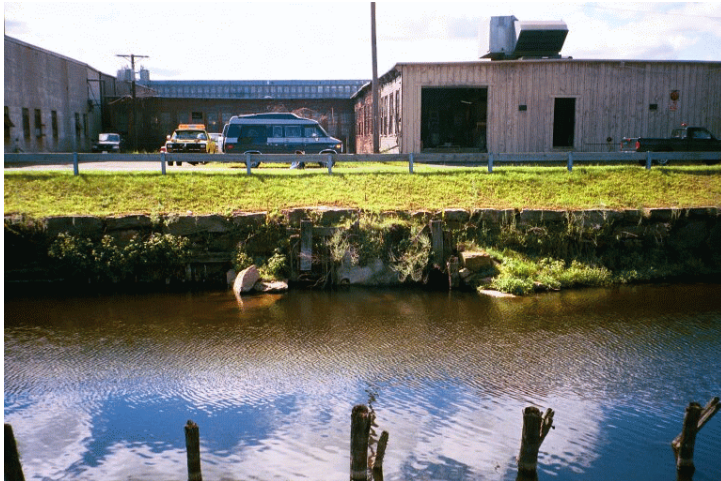
Pipe # 56:

Approximately 10' wide concrete culvert. Appears to be sealed. Island side. No flow.
